# EFFICACY OF RED AND YELLOW TURN ARROWS IN TRAFFIC SIGNALS

**November 1975**  
**Final Report**

**Prepared for**  
**FEDERAL HIGHWAY ADMINISTRATION**  
**Offices of Research & Development**  
**Washington, D. C. 20590**

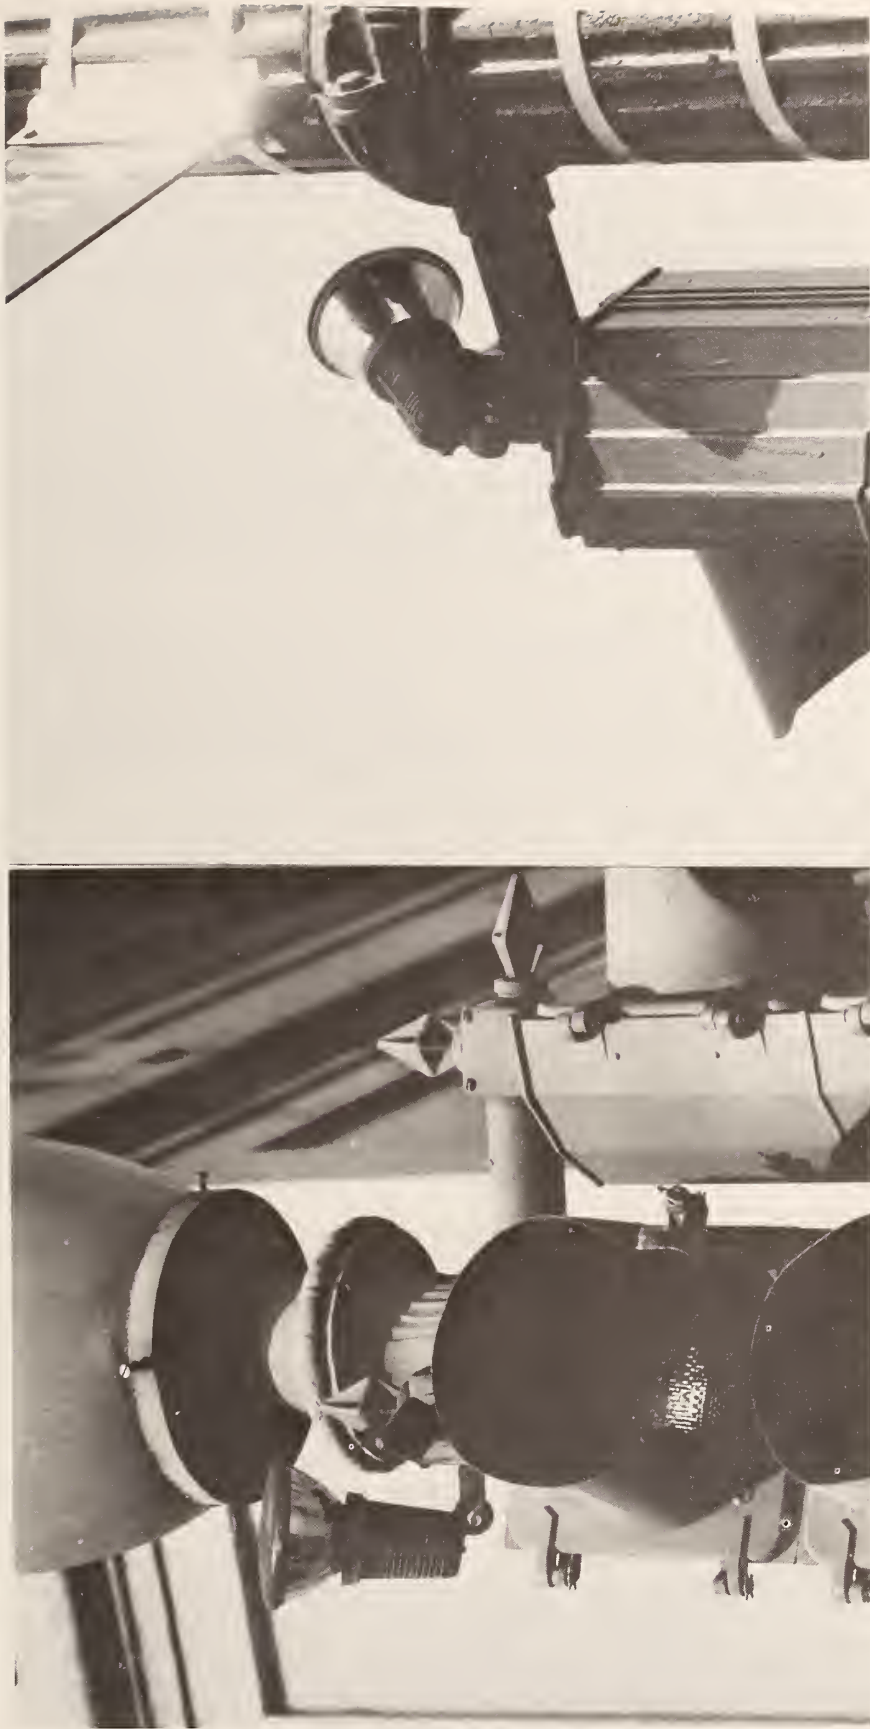
Figure 1  
Views of typical installations of the indicator lights.

At some locations it was difficult or impossible to see the signal operation adequately from the available filming location until a supplemental indicator light had been installed. This occurred at locations where: the camera was greater than about 300 feet from the studied signal; where the camera was significantly elevated above the street and the signal sunvisors blocked the camera's view of the signal changes; and/or where the filming position was behind the signal of interest. The supplemental indicator lights were standard outdoor floodlight lamps and their mountings, mounted on the tops of the signal heads, and wired into the signal controllers so as to be on when the signal of interest ( e.g. the green arrow ) was on. These indicator lights were aimed so as not to distract motorists but to be still visible from the camera locations. Figure 1 shows several views of typical installations of these indicator lights.

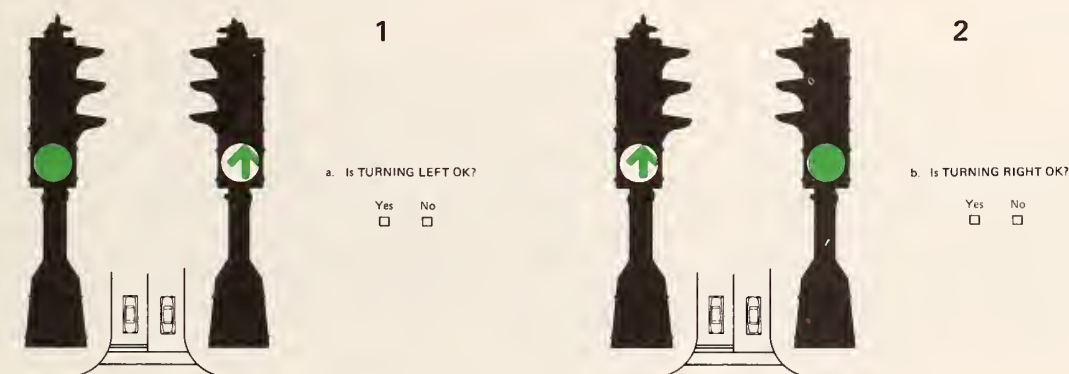
Figure 3. The illustrations for questions 1 and 2.

These two questions were an attempt to evaluate driver understanding of a signal display using a through green arrow on one far corner of the intersection with a green ball on the other corner. Such a display was considered for possible use to control approaches to an intersection where the cross street was one way. The intention was that the green arrow display would act to reinforce the conventional one-way signing and would further emphasize that the cross street was one-way so that a turn toward the corner with the arrow was illegal. Because of problems with the graphics and printing of the illustrations used for these two questions, they were hard to understand and the percentages of correct responses were completely unsatisfactory. The illustrations for these two questions are shown in Figure 3. In view of the severe problems with respondent understanding of these questions, it is perhaps best to make no judgement whatever, based on the questionnaire responses, as to the understandability or potential usefulness of such signal displays.

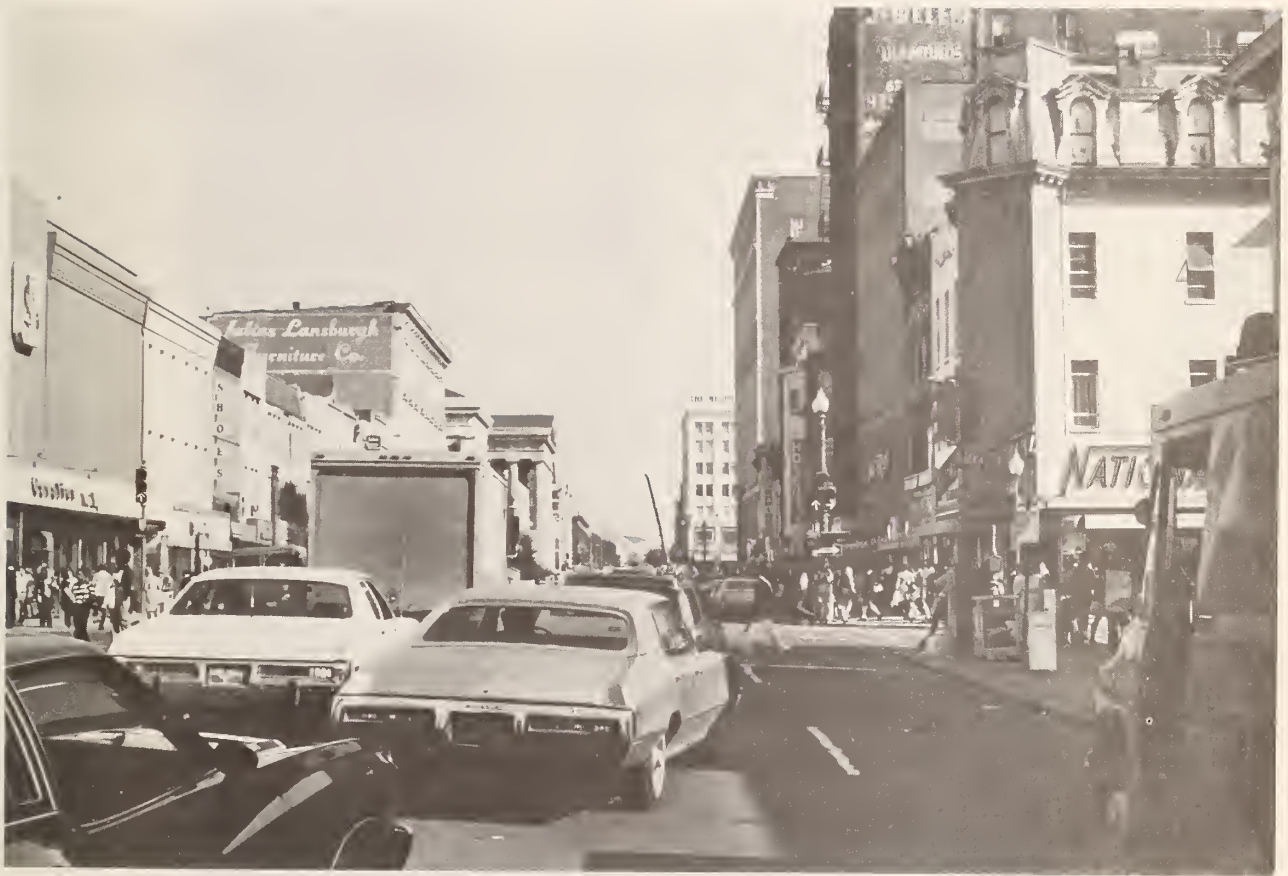
Eastbound views of the intersection of F and 10th Streets, N. W.  
(location # 09)

The Annual Average Daily Traffic (AADT) on this approach is 3,250 vehicles per day and running speeds are in the 25 mph range. Figure 19 shows the location. Figure 20 shows its signal operations in the "before" and "after" conditions.

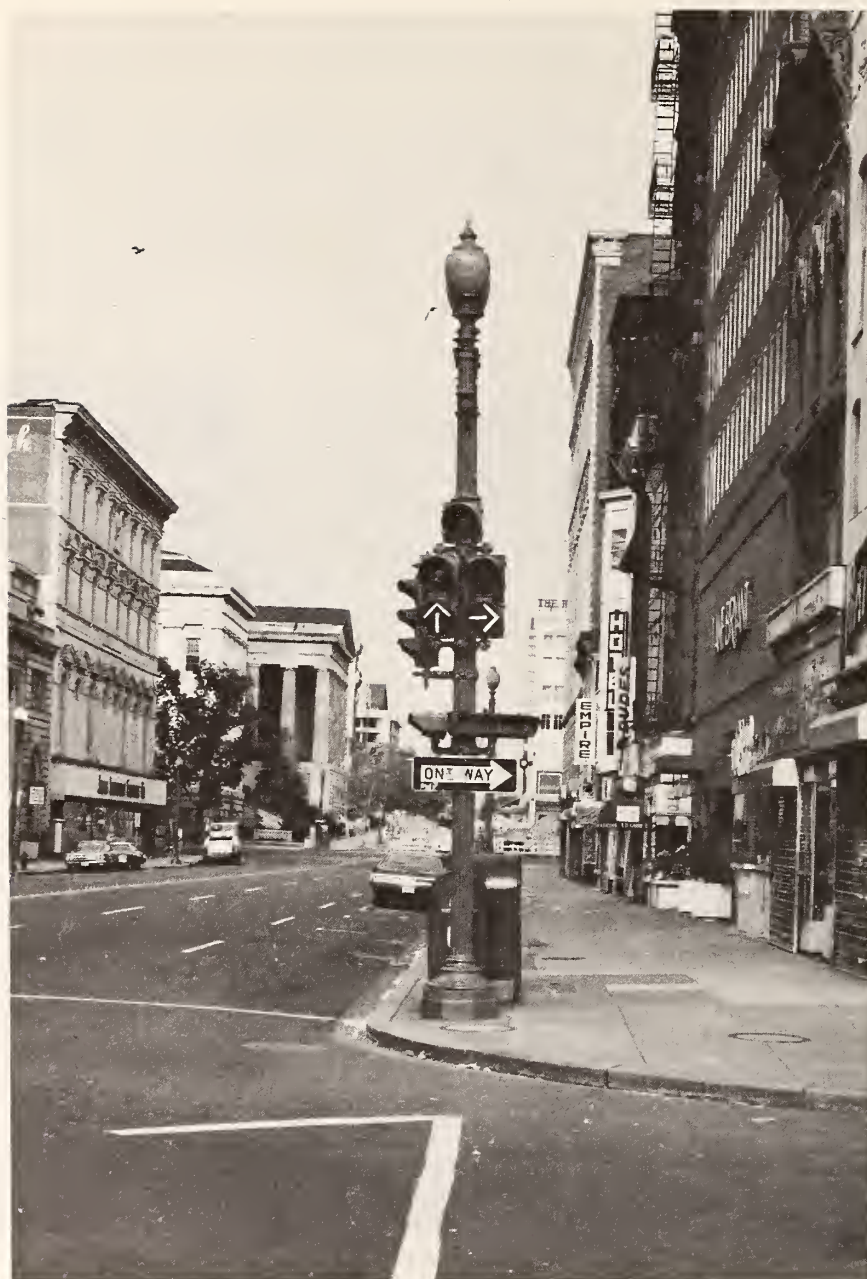
Figure 19 ( Continued )

In the "after" condition, traffic on this approach was controlled by a pair of five light signal heads, one of which was post mounted on each far side corner. The signal lights were installed in a "house" type arrangement. This had two vertical pairs of lights mounted side by side for the yellow and green indications, and a single light with a red ball lens centered above the two pairs. The left (green and yellow) pair controlled the through movement, and the right pair

The "after" condition.

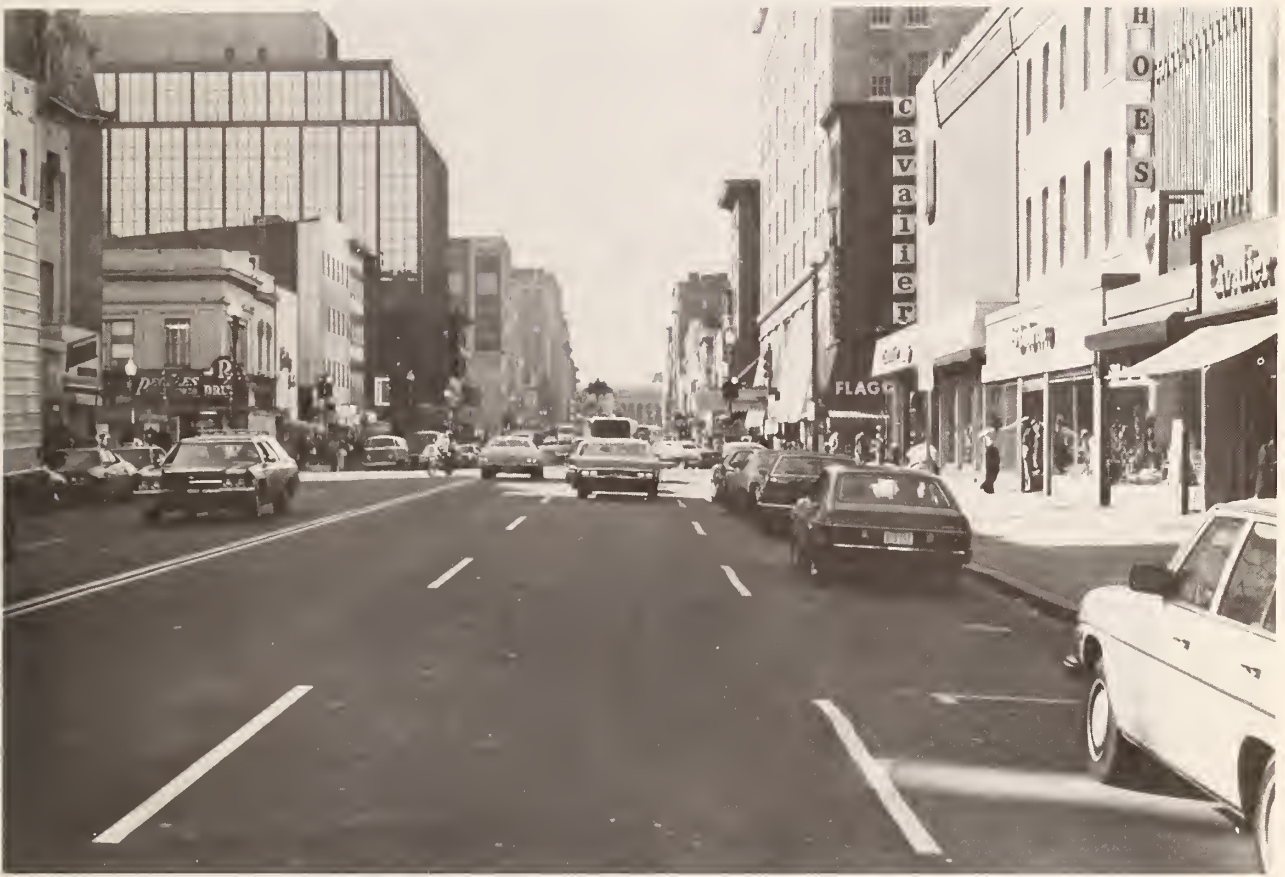
Westbound views of the intersection of F and 10th Streets, N.W.  
(location 19)

The AADT on this approach is 5,125 vehicles per day and running speeds are in the 25 mph range. Figure 21 shows the location, and Figure 22 shows its signal operations in the "before" and "after" conditions.

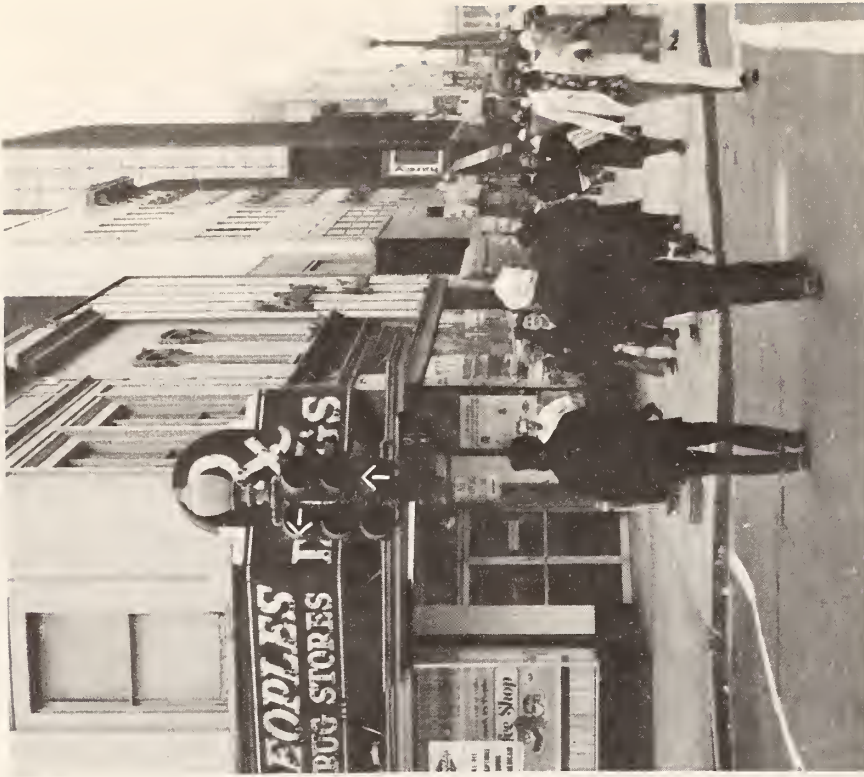
Figure 21 ( Continued )

In the "after" condition westbound traffic (using lanes one through three on the approach coded as Location # 19) was controlled by two pairs of three light signal heads, one pair on each far corner. The left side three light head of the six light assembly controlled the turn, while the right side three light head controlled the through movement. As can be seen from Figure 22, the signal indications cycled through: A red left arrow plus red ball display; a red left arrow plus green through arrow display; a yellow left arrow plus a yellow through arrow display; and then back to the red left arrow plus red ball display. All signals had 12 inch lenses. No signing was provided to explain the meaning of the arrow signal indications.

"After"

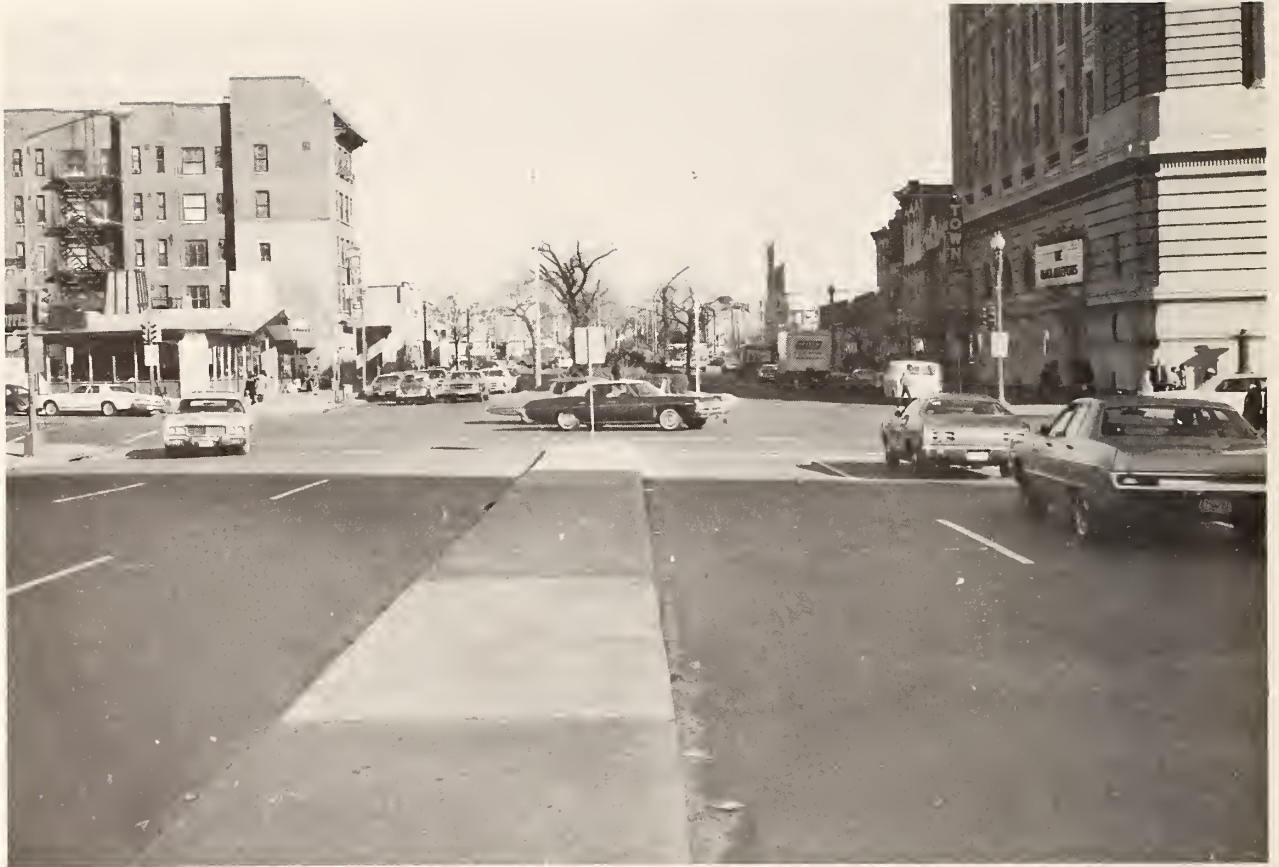
Figure 23

Views of the eastbound approach of New York Avenue  
to 13th Street, N.W.

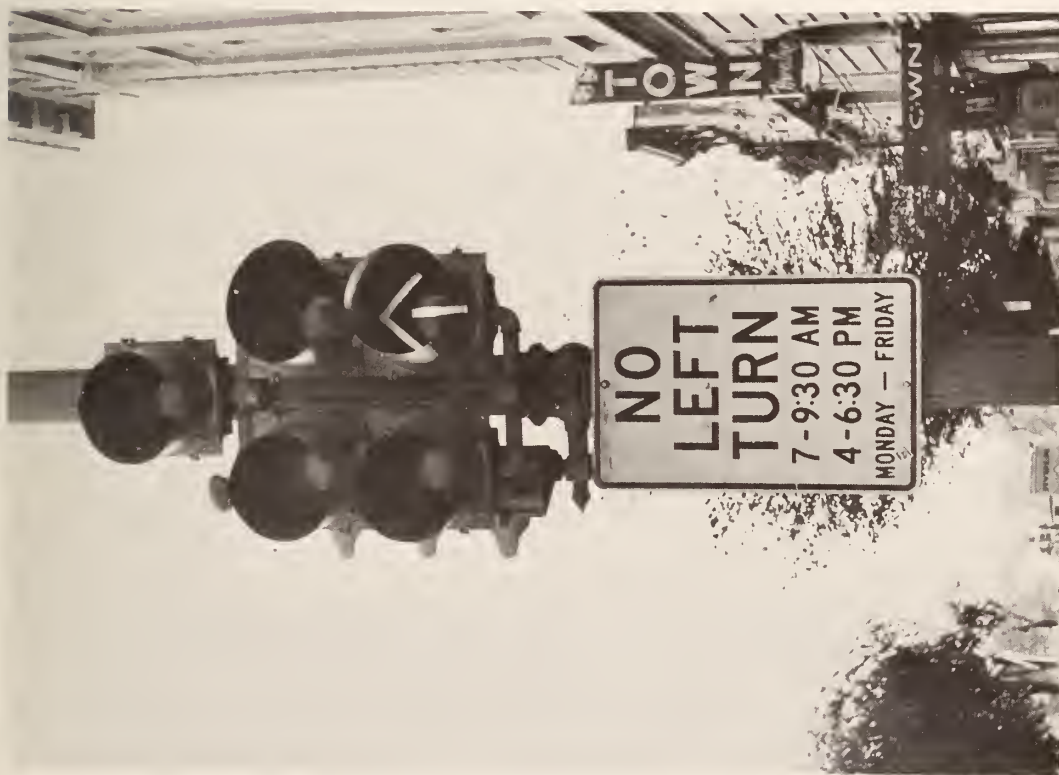
In the "after" portion of the study, the intent was to use an arrow display to call attention to the rush hour turn prohibition. Consequently a five light signal head with a "house" type arrangement of the lights (two side-by-side vertical two light pairs for the yellows and greens, with a single light for the red centered above those pairs) was installed. All lenses are 12 inch. The left (north) side pair of lights has green and yellow through arrow lenses. The right (south) side pair of lights has green and yellow ball display lenses. During periods when the left turn prohibition

"After" display during peak hours.

Note: In the "after" condition, during offpeak hours, conventional green and yellow circular signal indications are shown in the two lower left lens positions. The difference in the operations during peak and offpeak periods is shown in Figure 23.

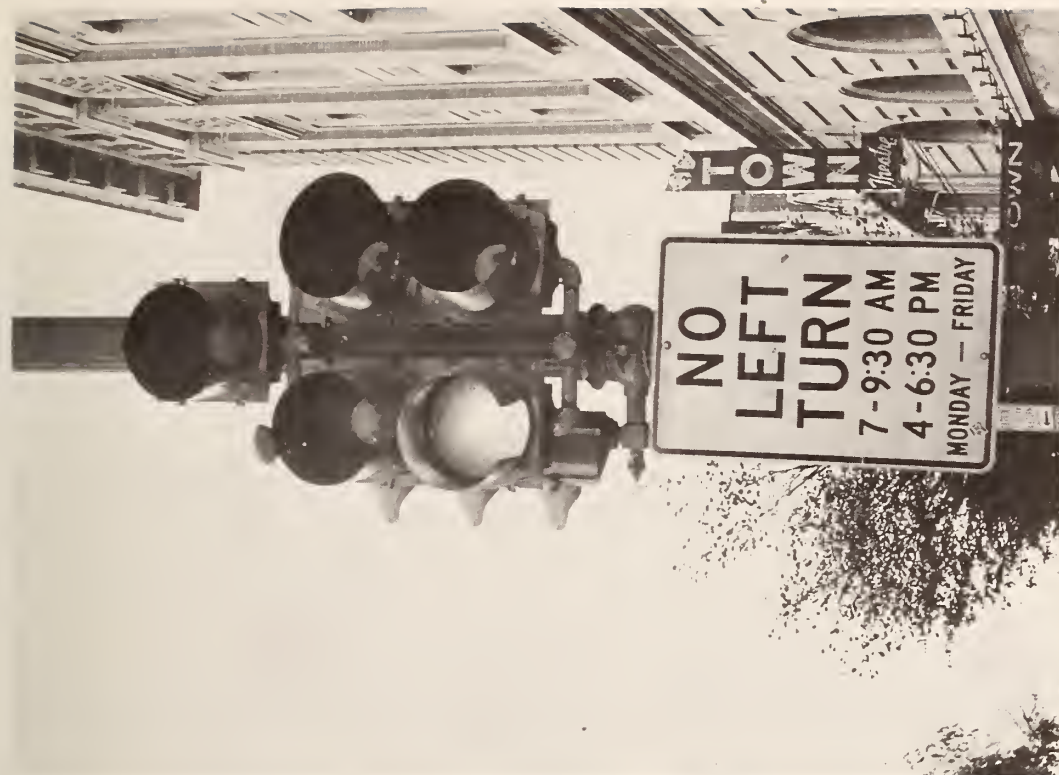
Figure 23 ( Continued )

"After" display during off-peak hours.

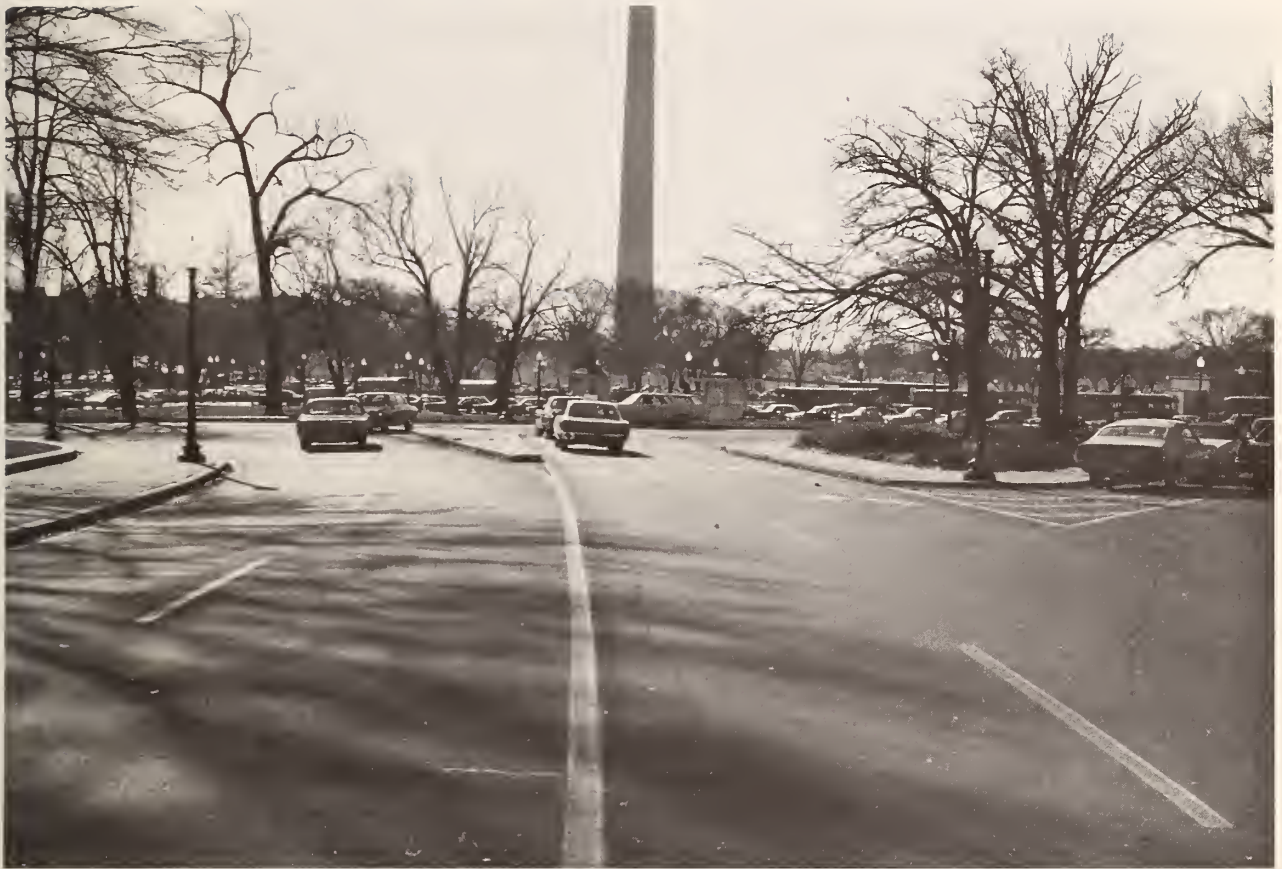
Figure 25

Views of the intersection of East Executive Avenue with E  
Street, N.W. (location 07)

and computer data analysis this location was designated by location reference number 07. A channelization island divides the southbound flow on East Executive, so the southbound East Executive traffic desiring to turn left and proceed eastbound on E Street moves on one side of the island, while the traffic desiring to turn right and head west on E Street travels along the other side of the channelizing island. In this study the movement of interest is the southbound to eastbound left turn. Two lanes are provided for this turn, and both are mandatory left turn lanes. A park (the "Ellipse") lies to the south of this "T" intersection. The location is shown in Figure 25. Its signal operations in the "before" and "after" conditions are shown in Figure 26.

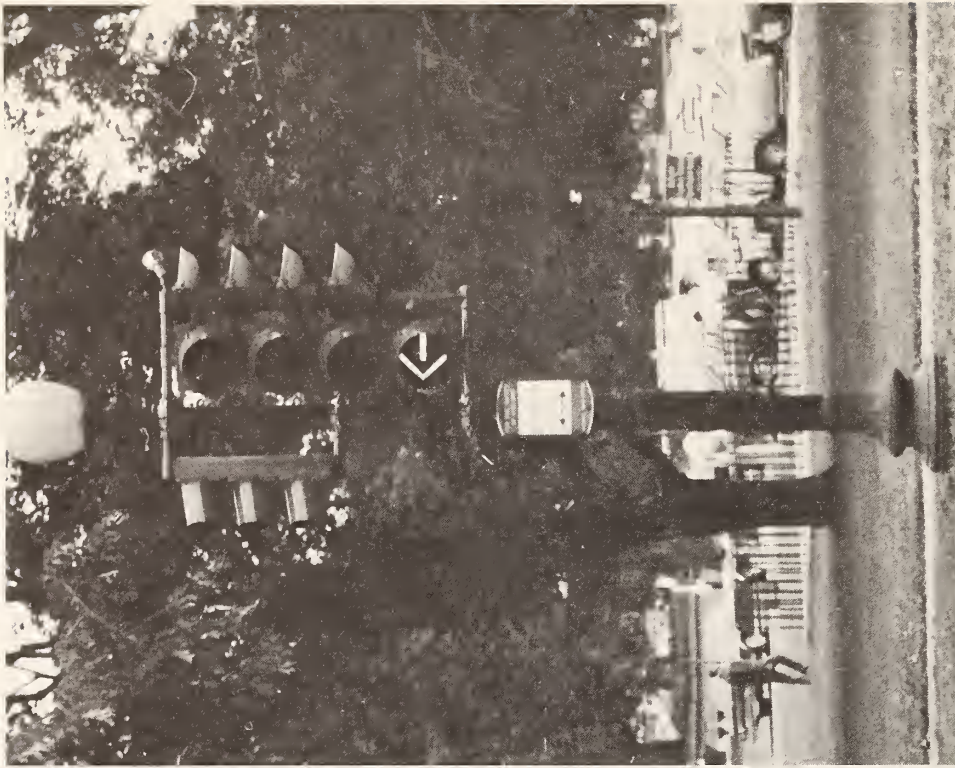
Figure 25 ( Continued )

No changes in signal timing or signal placement were made between the "before" and "after" conditions. In the "after" condition the signal had been converted to a four light head with all 12 inch lenses. The vehicular signal display was: red left arrow; green left arrow; yellow left arrow; and then back to red left arrow. The fourth (and highest) lens was a red ball which was used only in flashing operation during late night, malfunction, or emergency conditions. This fourth (ball) lens was required because flashing a red arrow is not authorized by the M.U.T.C.D., and because our interpretation of M.U.T.C.D. Subsection 4B-18 is that it requires all traffic signals to be operable in the flashing mode. No special signing was provided to explain the arrow signal indications.

The "After" condition

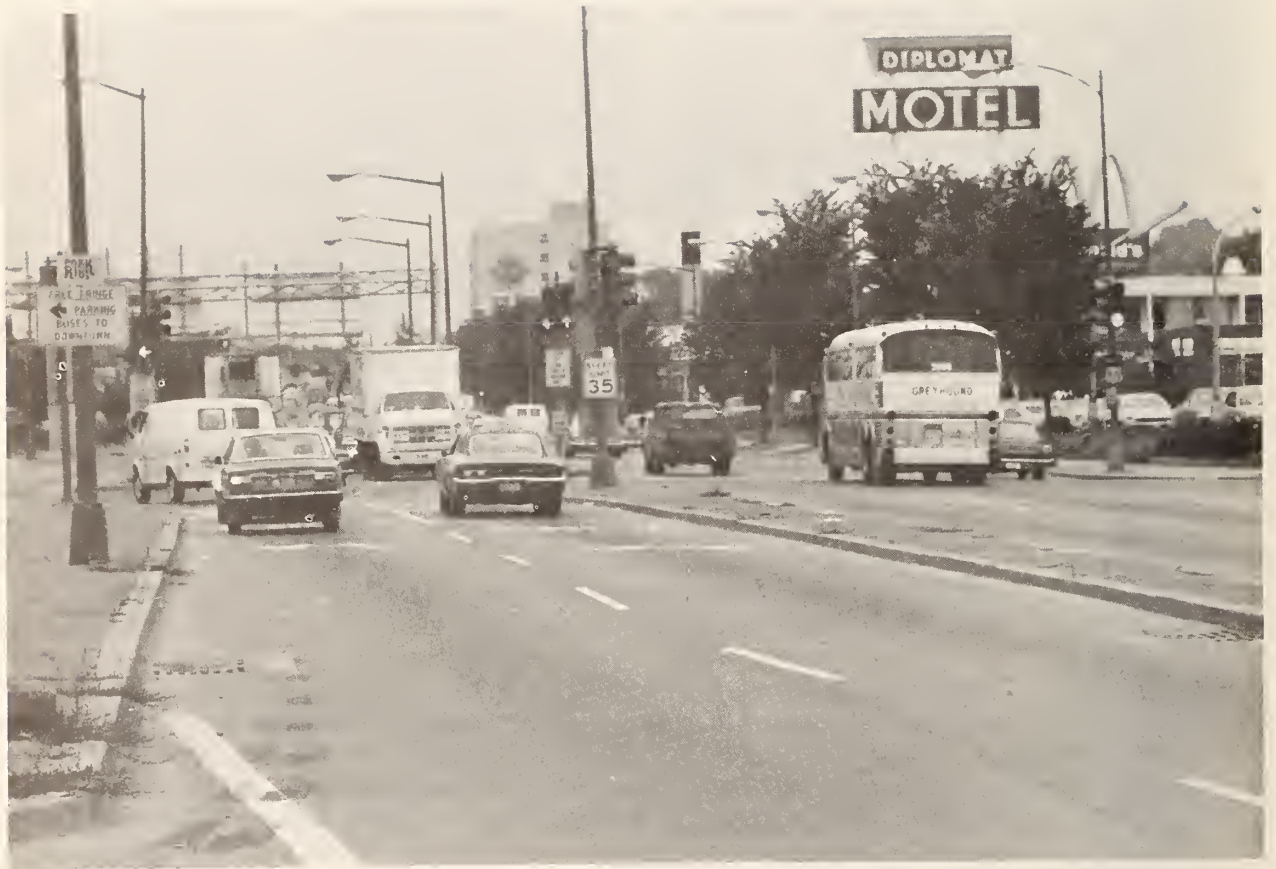
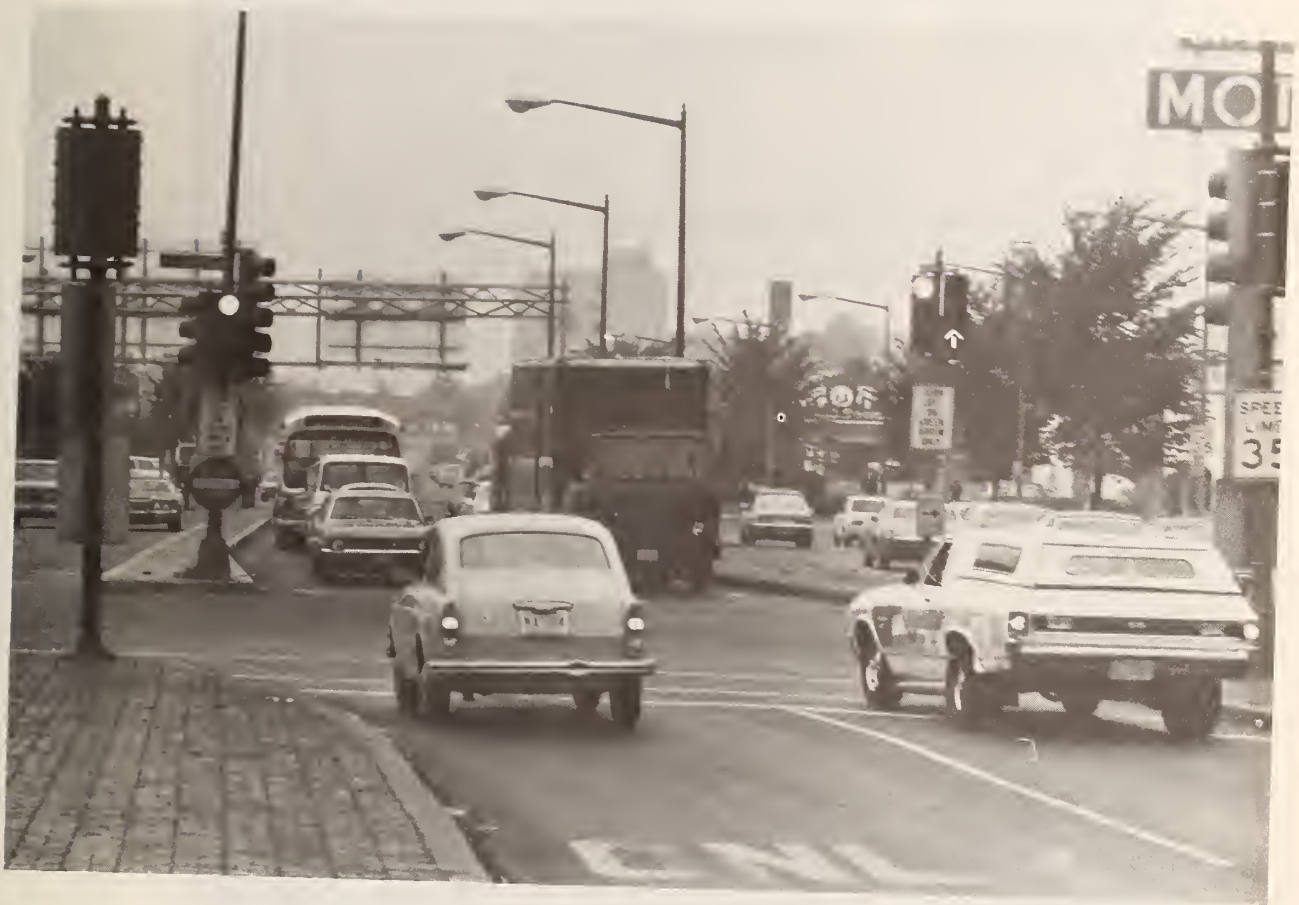
Views of the westbound approach of New York Avenue to its intersection with Bladensburg Road, N.E. (location 11).

The experimental location for this part of the study is the intersection of New York Avenue with Bladensburg Road, N.E. This location is on a primary arterial route near the eastern border of the District of Columbia in an area with tourist services and industrial and warehousing land uses. Figure 27 shows the location. Figure 28 shows its traffic signal operations in the "before" and "after" conditions. The site was assigned location reference number 11 for film scoring and computer data analysis purposes.

The traffic movement of interest is a left turn from westbound New York Avenue onto south-westbound Bladensburg Road. The change of direction of a turning vehicle is approximately 60 degrees. This location has been channelized to provide an exclusive left turn slot separated by raised islands from both the opposing traffic and from through vehicles continuing westbound. Two turning lanes are provided to meet the high turning demand. The westbound to south-westbound left turn is signal controlled with a lagging protected turn and a "prohibited then protected" operation. The turn is prohibited during the interval when both eastbound and westbound through traffic flow. Then the opposing (eastbound) through traffic is stopped and the left turn has a protected movement, while the westbound through movement continues. The turn is controlled by dual far side signals post mounted on the islands of the channelization for a similar left turn channelization for eastbound New York Avenue traffic. The traffic signals are operated by a three dial, fixed time, controller.

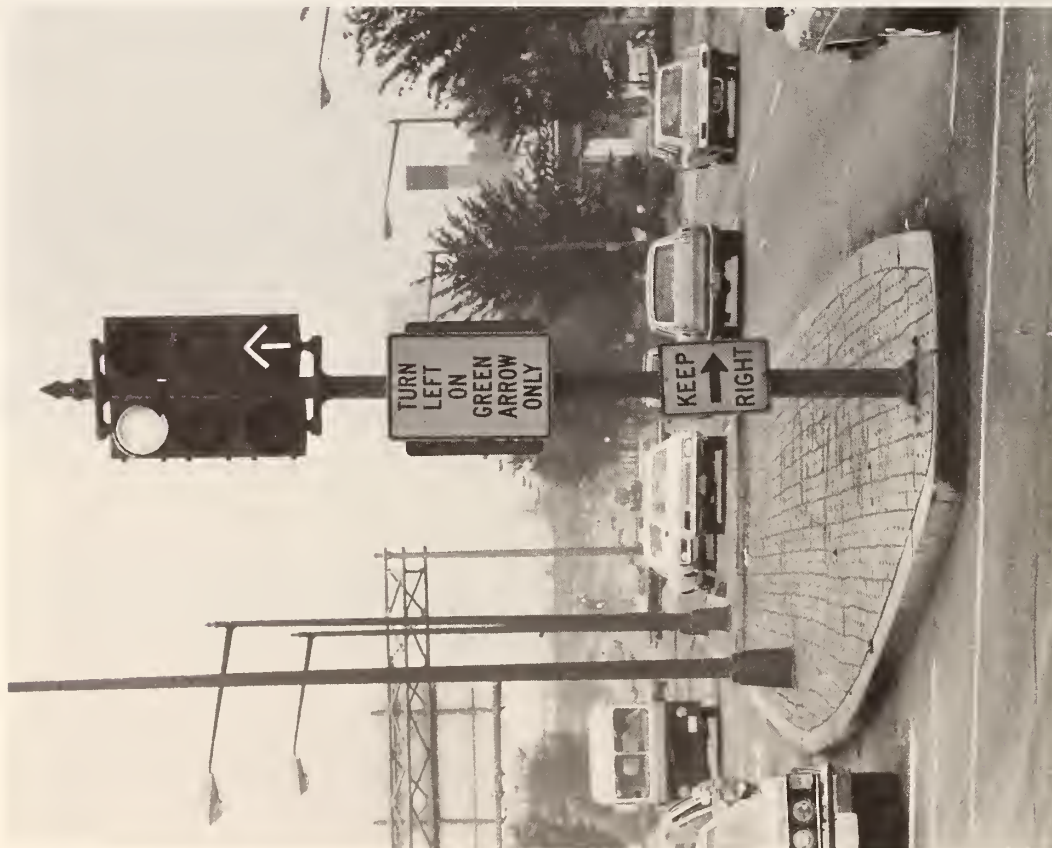
The signal in the "before" condition.

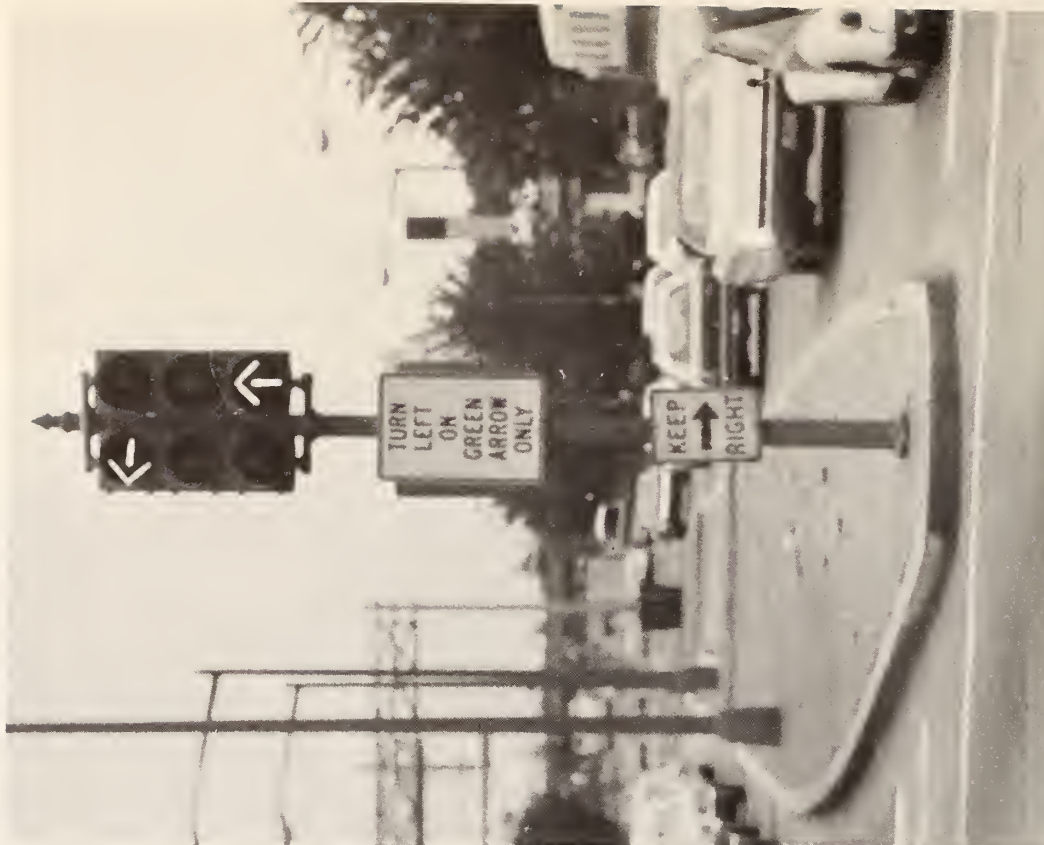
Figure 27 ( Continued )

The signal in the "after" condition.

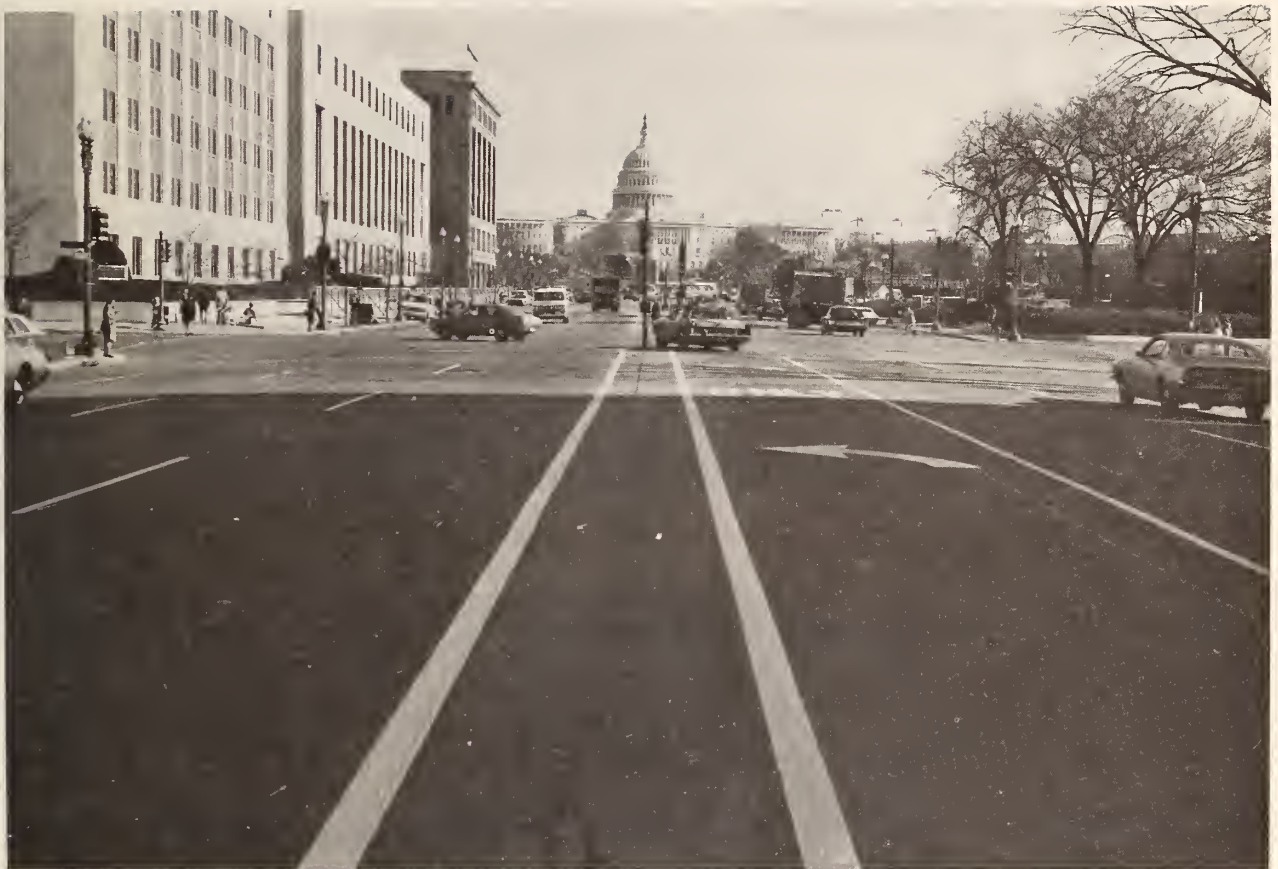
Figure 29

Views of the eastbound approach of Pennsylvania Avenue  
to 6th Street, N. W. ( location # 01).

The traffic movement of interest at this location is a left turn from eastbound Pennsylvania Avenue onto northbound 6th Street. A painted median with an exclusive left turn slot type channelization is provided. This left turn slot provides a fourth lane for the eastbound approach. The left turn is prohibited during the first portion of the eastbound through movement, and is then protected during the remainder of the eastbound through movement. A post mounted far side signal in the median serves as the primary control for the left turn, as well as being the supplemental signal for the through movement. A secondary left-turn signal is post mounted on the north east corner of the intersection. A far-side post mounted signal on the south-east corner serves as the primary signal for through movements and also serves as the indication for right turns (eastbound to southbound) and pedestrians. The location is shown in Figure 29. The signal operations for the eastbound approach in the "before" and "after" conditions are shown in Figure 30.

During the "after" condition, the median mounted signal was changed to a pair of side by side, three light heads with all 12 inch lenses. The left head was the primary signal for the left turn, while the right head was the supplemental signal for the through movement. The signal sequence for this pair of heads was: red left arrow plus red ball; red left arrow plus green through arrow; green left arrow plus green through arrow; yellow left arrow plus yellow ball; and then back to the red left arrow plus red ball. The supplemental turn signal on the northwest corner was changed to a three light, all 12 inch lens head, with red left arrow, green left arrow, and yellow left arrow indications. No signs to explain the arrow indications were provided.

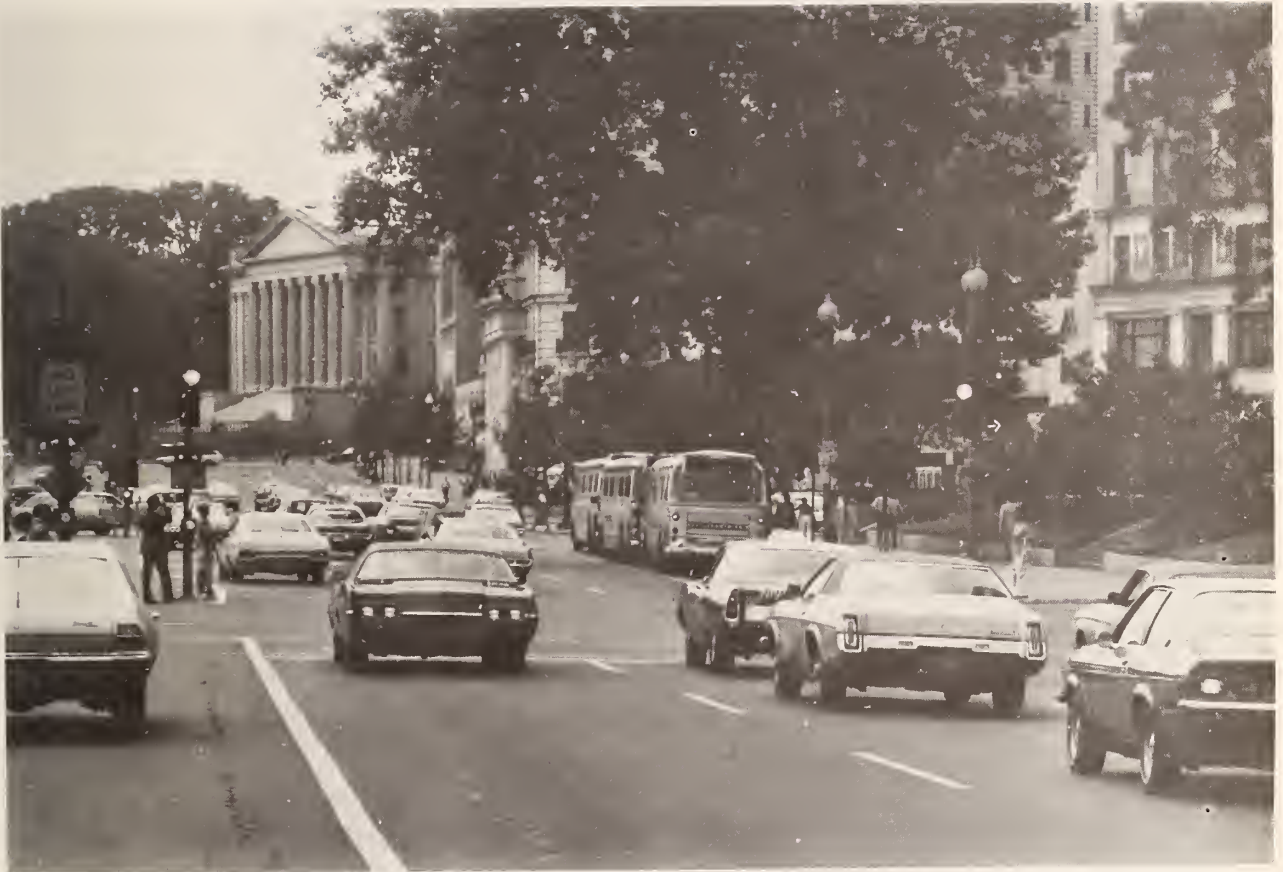
Figure 31

Views of the westbound approach of Pennsylvania Avenue to  
13th Street, N. W. (location # 03).

The traffic movement of interest at this study site was a right turn by westbound Pennsylvania Avenue traffic onto northbound 13th Street. In order to protect a substantial east-west pedestrian movement between the northeast and northwest corners of the intersection, the right turn is prohibited throughout the through movement. The pedestrians move with the through traffic. Then the through and pedestrian movements are stopped, and the right turns have a protected movement immediately following the end of the yellow clearance interval for the through phase. The southbound traffic on 13th Street gets its green indication during the same phase as the right turn off of westbound Pennsylvania Ave. Because of heavy through bus usage of the westbound curb lane, and the presence of a nearside bus stop, it was not possible to provide an exclusive lane for the westbound to northbound right turn. Thus, both through movements and right turns were permitted from the curb lane (described and coded as Lane #1). No left turns were permitted from this approach. The location is shown in Figure 31, and the signal operations on its westbound approach are shown in Figure 32.

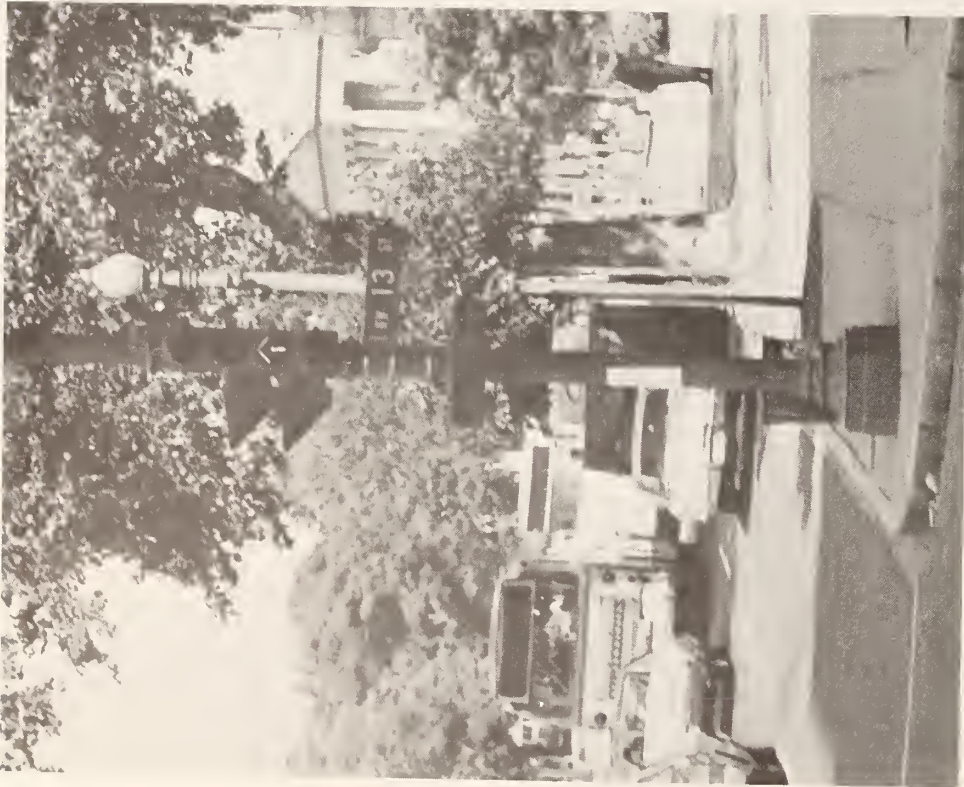
During the "before" condition, the movements were controlled by a single four light signal head with all eight inch lenses, on a far side pole mounting on the northwest corner. The vehicular signal display sequence was: red ball; green through arrow alone; yellow ball; red ball plus green right arrow; red ball plus yellow ball; and then back to the red ball alone. A supplemental indication was provided for through traffic by a far side pole mounted signal in the median.

The signal in the "before" condition.

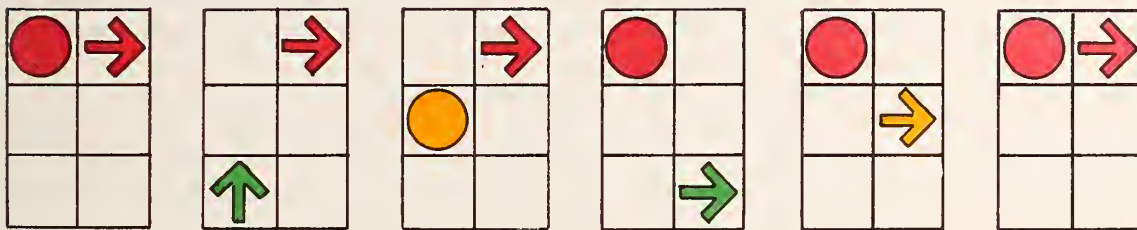
Figure 32

Signal displays in the "before" condition.

Signal displays in the "after" condition.

During the "after" condition the westbound movements were controlled by a pair of three light, 12 inch lens, signal heads in a far side pole mounting on the northwest corner. All indications for the through movement were shown in the left signal head of the pair, and all indications for the right turn were shown in the right signal head. The vehicular signal display sequence was: red ball plus red right arrow; green through arrow plus red right arrow; yellow ball plus red right arrow; red ball plus green right arrow; red ball plus yellow right arrow; and then back to red ball plus red right arrow. No explanatory signing was provided. As in the "before" condition, supplemental indications were provided for the through movement by a post mounted, far side signal in the median.

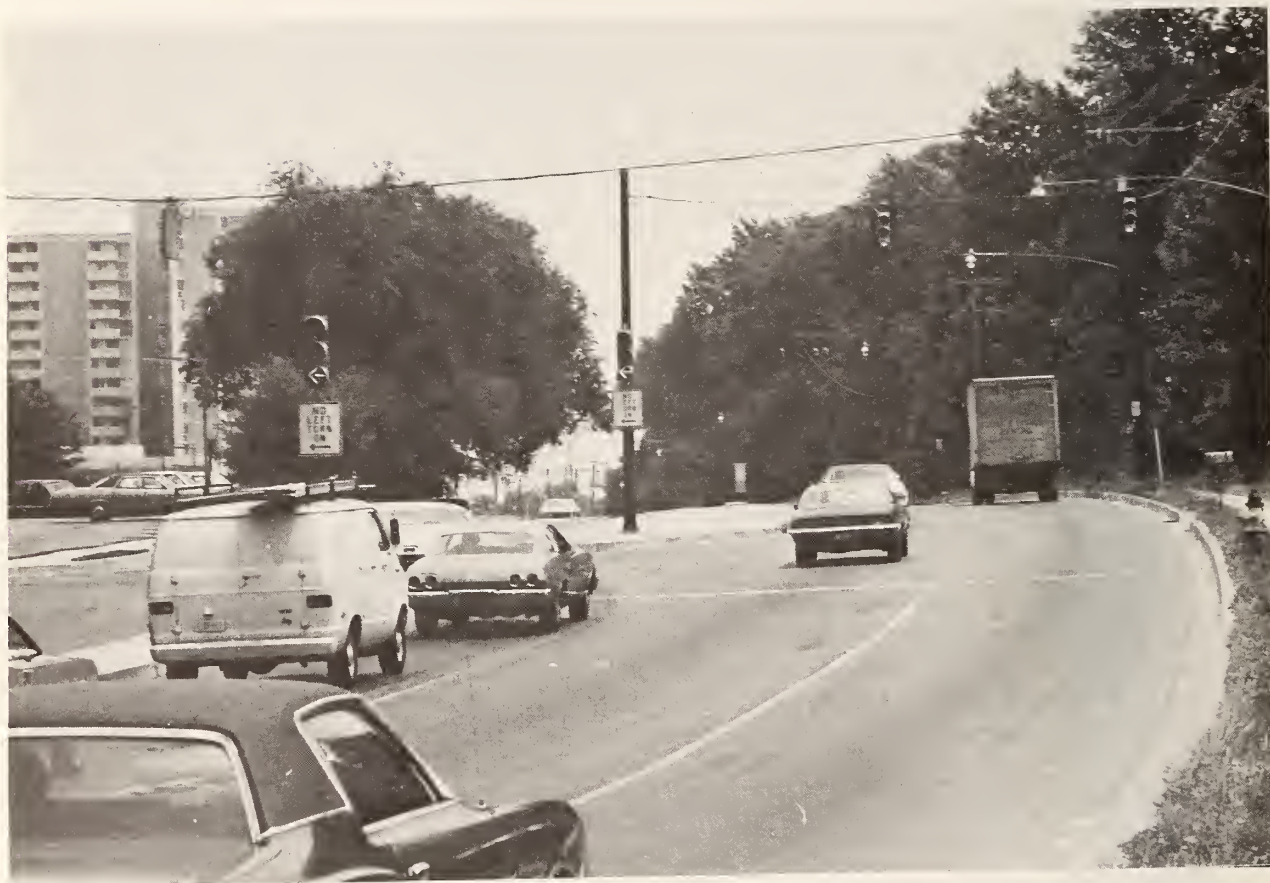
Figure 33

Views of the eastbound approach of Montrose Road to Jefferson  
Street (location 21)

The study site was the intersection of Montrose Road with Jefferson Street. Montrose Road was an east-west primary arterial route. At this location it had two lanes in each direction for through traffic, plus an exclusive left turn lane for eastbound traffic desiring to turn north onto Jefferson Street. Montrose Road had a raised median on both sides of the intersection but no access control. Jefferson Street had four lanes undivided, and ran from this "T" intersection northward, providing high type collector service to apartments and to the back of a shopping center. The location is shown in Figure 33. This site was assigned location reference number 21 for film scoring and data analysis purposes.

In the "after" condition "No Left Turn on (red arrow symbol)" signs were mounted immediately below both the near and far side median mounted left turn signals. These signs may be seen in several of the views of the location presented in Figure 33.
